Engine 110 model year 1974, California Emission Control System

Engine 117 model year 1974, California Emission Control System

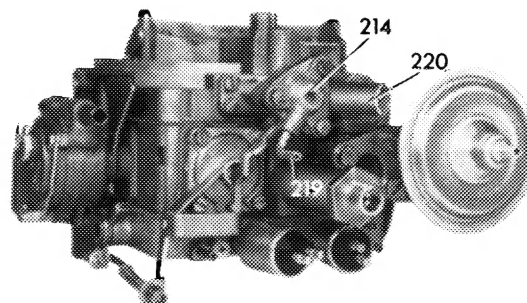
107-8977

Turn off engine. Disconnect grey vacuum line of the float chamber vent valve (214) at the connection on the carburetor.

Result:

There should be no vacuum present. Reconnect vacuum line.

Test No. 2

Start engine and again remove vacuum line.

Vacuum should be present (hissing sound).

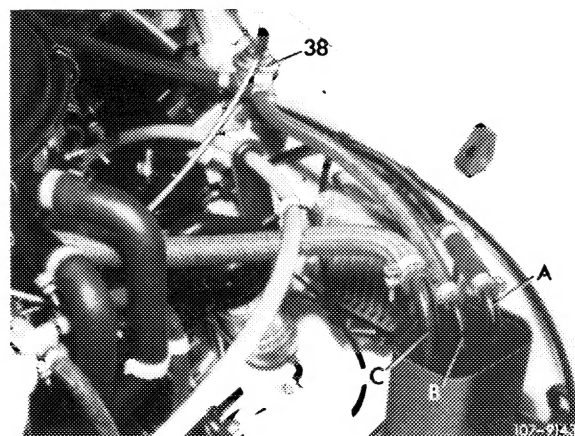
Test No. 3

Remove the thin center hose on the charcoal canister (B) and close the hose opening with your finger. Increase engine speed slowly to more than 2000/min.

Result:

During idle, a slight vacuum should be present. The vacuum should increase with rising engine speed.

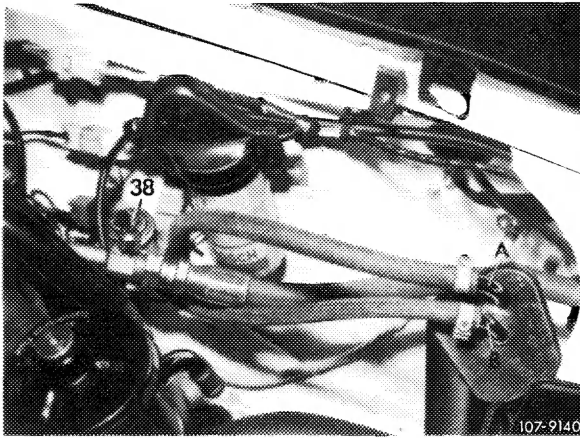
**Test**

Remove the thin hose on the charcoal canister (B) and close the hose opening with your finger. Increase engine speed slowly to more than 2000 rpm.

Result:

During idle, a slight vacuum should be present. The vacuum should increase with rising engine speed.
